EXTERIOR REHABILITATION PLAN FOR HISTORIC HOUSE  
34653 FREMONT BOULEVARD | FREMONT, CA

**SIEGEL & STRAIN** Architects

July 21, 2014

34653 Fremont Boulevard, Fremont, California

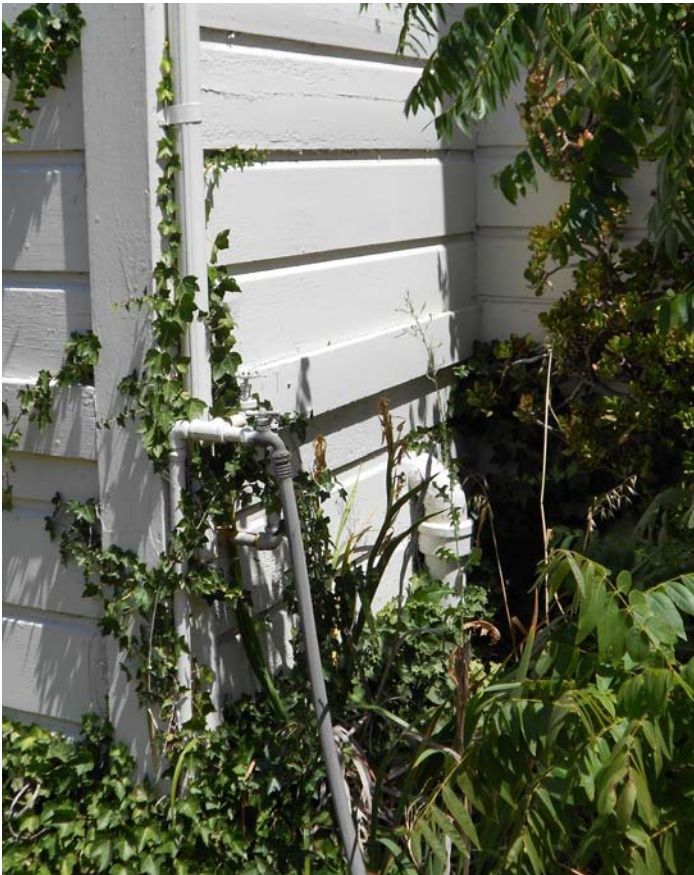
Figure 47: Overgrown vegetation at southwest corner of bathroom wing, west elevation. (July, 2014) (S&S)

- › Cut back overgrown vegetation adjacent to the structure.
- › Vegetation holds moisture against the wood siding and accelerates its deterioration. It also provides habitat for wood damaging insects and animals. It also causes abrasion and impact damage.
- › Trim and maintain vegetation adjacent to the structure (especially at northwest corner of house) to enhance visibility from public street and sidewalk.
- › Retain sufficient spatial openness surrounding the house to convey the property's single-family residential use.
- › Retain historic concrete path between public sidewalk and front porch and partially encircling the house. Replace in kind in areas where missing.
- › Plant vegetation to visually buffer the house from new construction at the site.

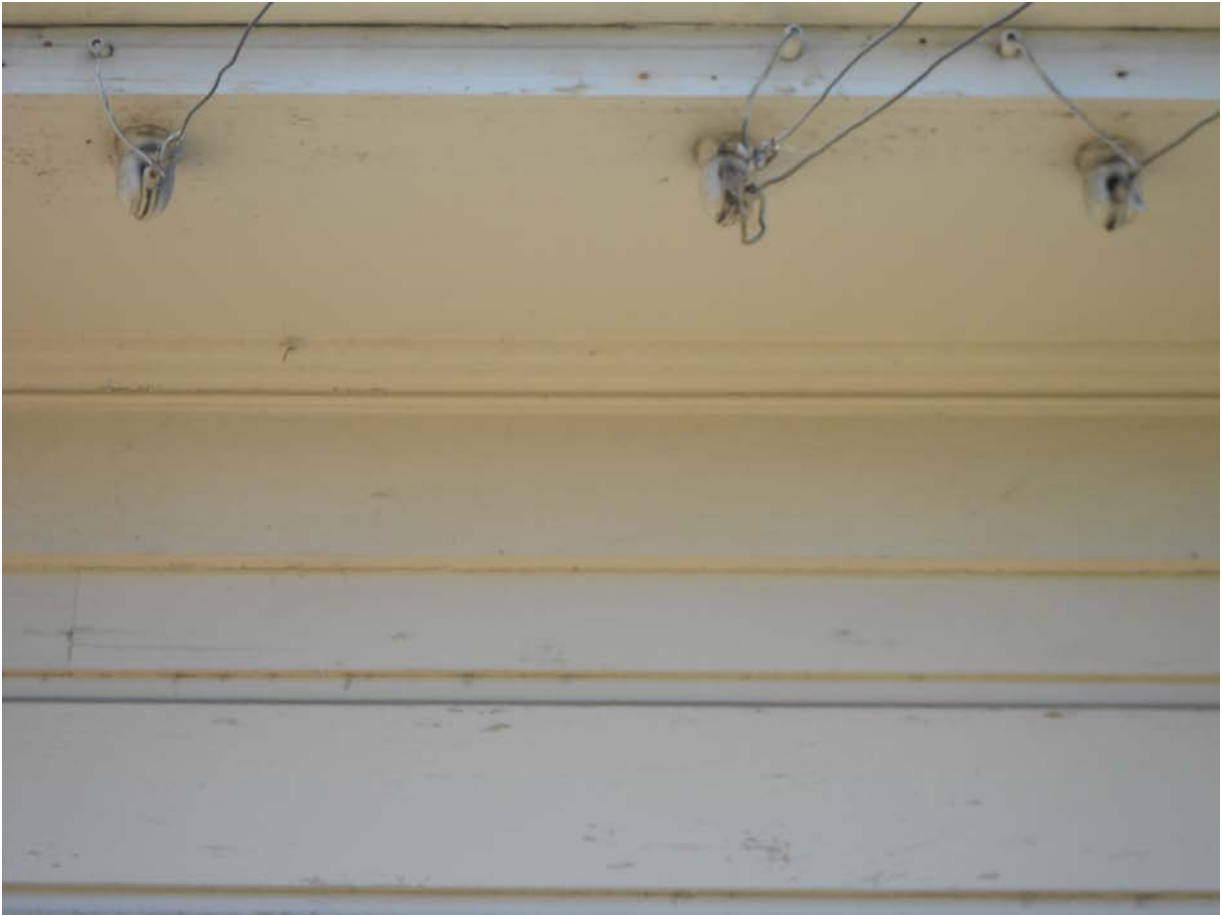
Figure 49: Abandoned surface mounted attachments should be removed and wood elements patched. (July, 2014) (S&S)

- › Remove abandoned surface mounted electrical wires and equipment and patch holes.
- › Removed abandoned hose bibs
- › Remove abandoned exhaust flues
- › Remove abandoned surface mounted telephone equipment and wires and patch holes.
- › Remove abandoned metal attachments and patch surface.
- › Relocate meters to less visible location or conceal in wood cabinet.
- › Remove window air conditioning unit on east.
- › Remove antennae from east side of the house.

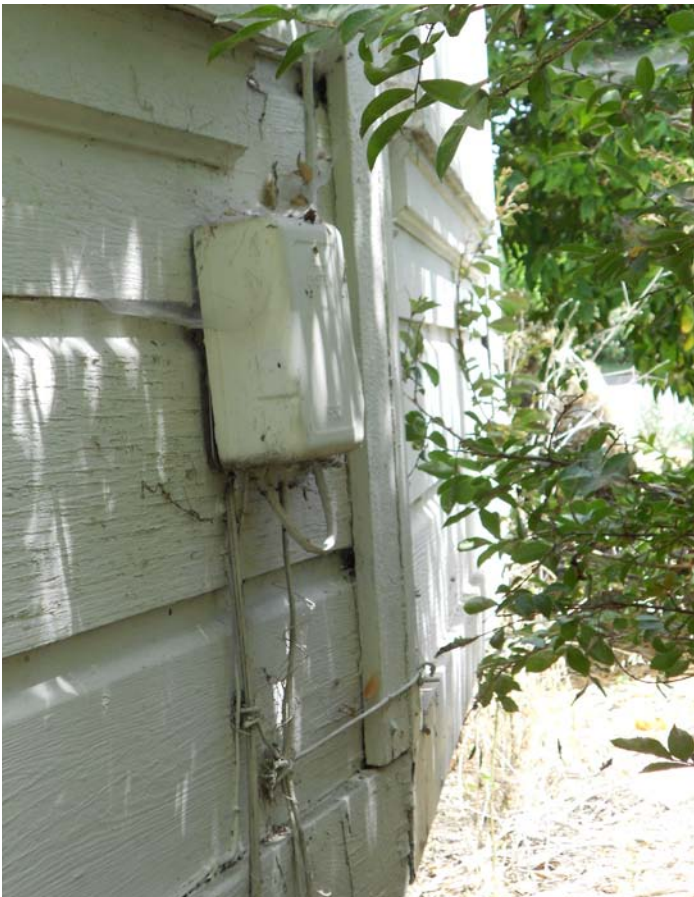
Figure 50: Abandoned surface mounted telephone equipment should be removed and wood siding patched. (July, 2014) (S&S)

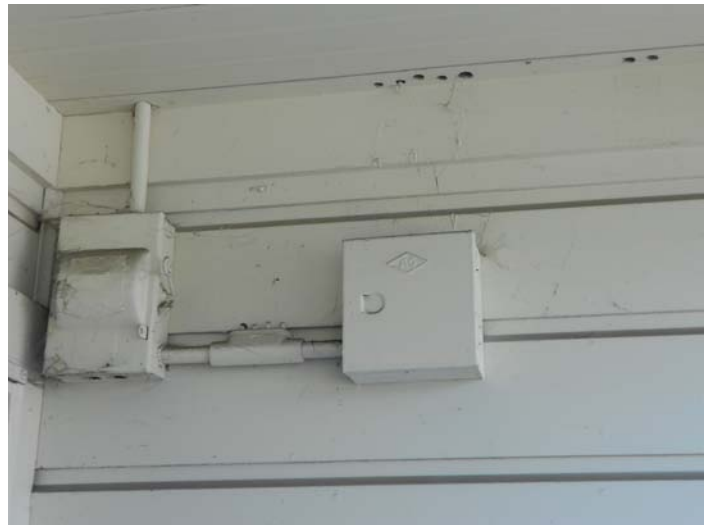
Figure 51: Surface mounted electrical equipment should be relocated and wood siding and soffit patched. (July, 2014) (S&S)
